Test Report No. TRPVP07120/23P/01

Performance Measurement about PV Modules

Applicant: **Guangdong Lesso Banhao New Energy Technology Group Co., Ltd**
Liansu Industrial Estate, Longjiang, Shunde, Foshan, Guangdong, China

Module types 565C(HBD)72(182) and 655D(HBD)66(210) were delivered to testing lab as test samples and conducted with all the related tests.

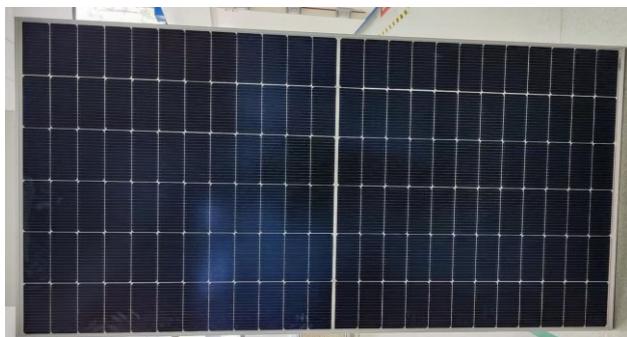
Front overview

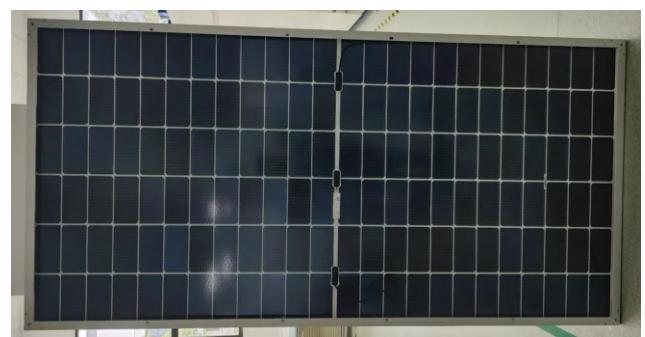
Back overview

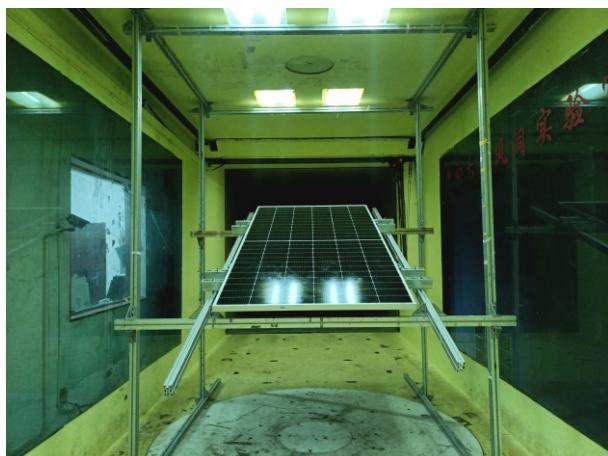
Test at Windward-Attack Angle 20°

WIND TUNNEL TEST							
Clause	Requirement + Test		Result - Remark		Verdict		
6 Wind tunnel test					-		
Test date [MM/DD/YYYY] / start - end :	08/28/2023						
Sample #..... :	1						
The direction of the wind	Windward						
Wind attack angle	20	20	20	20	-		
Wind velocity [m/s]..... :	10	35	45	60	-		
Duration [minute]	1	1	1	10	-		
The direction of the wind	Leeward						
Wind attack angle	20	20	20	20	-		
Wind velocity [m/s]..... :	10	35	45	60	-		
Duration [minute]	1	1	1	10	-		
Supplementary information: N/A

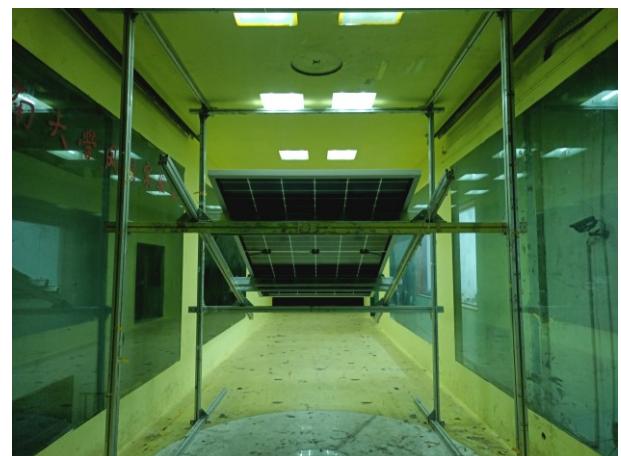
Test at Leeward-Attack Angle 20°

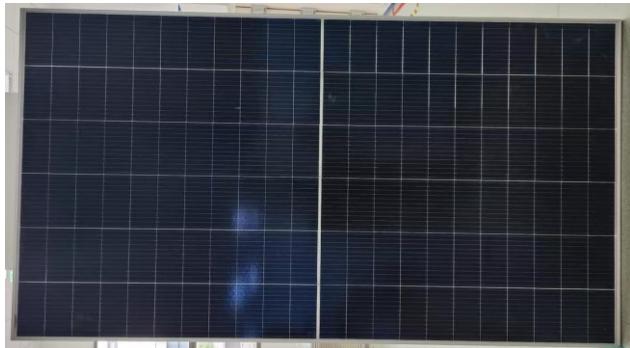
Front overview

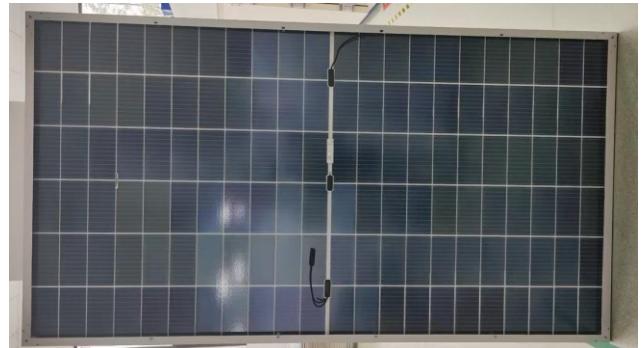
Back overview

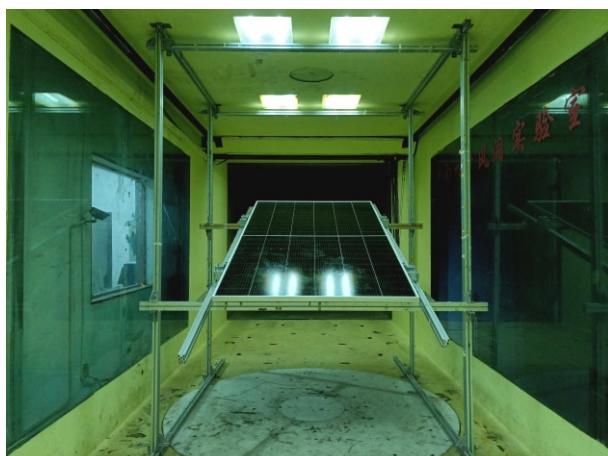
Test at Windward-Attack Angle 20°

WIND TUNNEL TEST							
Clause	Requirement + Test		Result - Remark		Verdict		
6 Wind tunnel test					-		
Test date [MM/DD/YYYY] / start - end :	08/28/2023						
Sample #..... :	2						
The direction of the wind	Windward						
Wind attack angle	20	20	20	20	-		
Wind velocity [m/s]..... :	10	35	45	60	-		
Duration [minute]	1	1	1	10	-		
The direction of the wind	Leeward						
Wind attack angle	20	20	20	20	-		
Wind velocity [m/s]..... :	10	35	45	60	-		
Duration [minute]	1	1	1	10	-		
Supplementary information: N/A

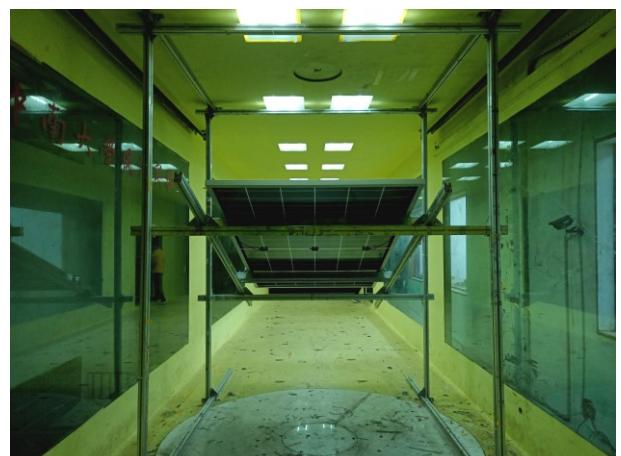
Test at Leeward-Attack Angle 20°
