Prüfbericht-Nr.: <i>Test report no.:</i>	CN24H5WU 001	Auftrags-Nr.: <i>Order no.:</i>	170370364	Seite 1 von 9 Page 1 of 9
Kunden-Referenz-Nr.: <i>Client reference no.:</i>	2411166	Auftragsdatum: <i>Order date:</i>	2024-01-30	
Auftraggeber: <i>Client:</i>	Guangdong Lesso Banhao New Energy Technology Group Co., Ltd The 1st and 2nd floors of the workshop in Zone 2, No. 58, Longzhou West Road, Longjiang Town, Shunde District, Foshan City, 528318 Guangdong, P.R. China			
Prüfgegenstand: <i>Test item:</i>	PV module installed on racking system			
Bezeichnung / Typ-Nr.: <i>Identification / Type no.:</i>	570C(HBD)72(182)			
Auftrags-Inhalt: <i>Order content:</i>	Wind load resistance performance test for PV module installed on racking system			
Prüfgrundlage: <i>Test specification:</i>	According to client's requirement			
Wareneingangsdatum: <i>Date of sample receipt:</i>	2024-02-01

1	Produktdetails <i>Product details</i>	Double glass PV module installed on the racking system with tilt angle 20°
2	Maße / Gewicht <i>Dimensions / Weight</i>	<p>L*W*H</p> <p>1) Double glass PV module with type 570C(HBD)72(182): 2278*1134*35 mm</p> <p>2) Racking system Front post: U41x72x2.5, L=563 mm Back post:

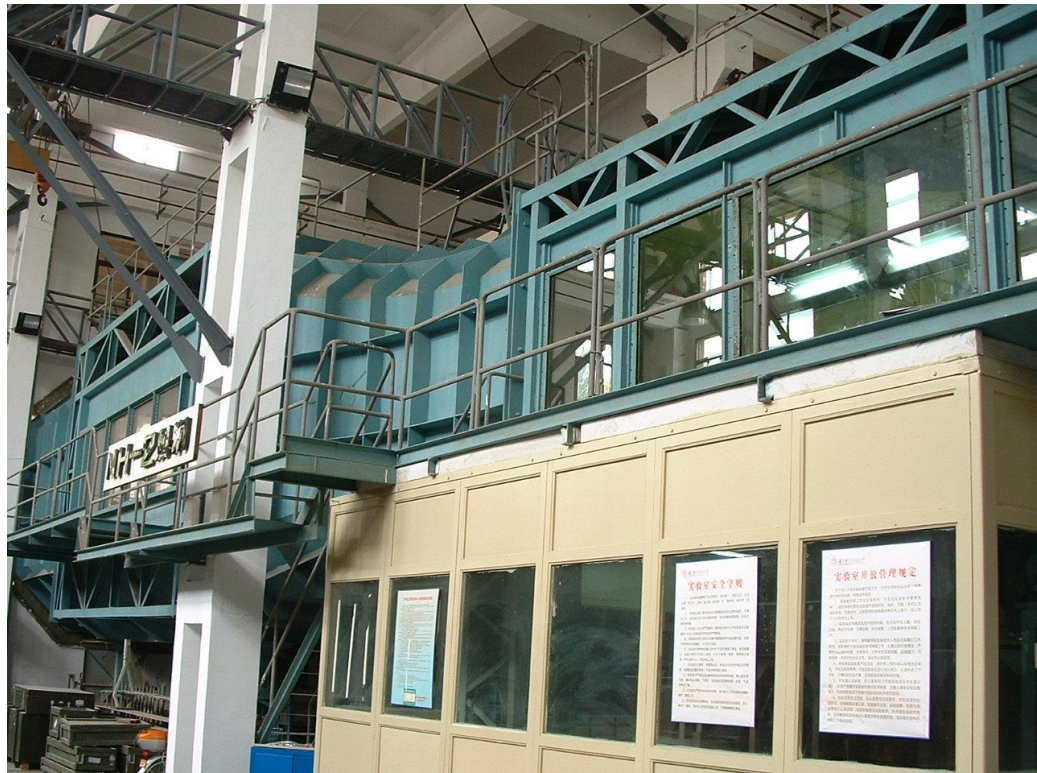
Figure 1. NH-2 wind tunnel facility

This test was carried out in the small test section of NH-2 low-speed wind tunnel laboratory. Wind pressure and wind speed can be read via anemometer installed in the test section. NH-2 low-speed wind tunnel is an all-steel tandem double-test section closed-mouth return wind tunnel, and the main technical properties of the small test section where this test is located are as follows:

- Width x height x length: 3.0 m x 2.5 m x 6.0 m
- Cross-sectional area of the inlet: 7.18 m²
- Maximum wind speed: 90 m/s
- Minimum stable wind speed: 5 m/s
- Mean airflow declination: $\Delta\alpha \leq \pm 0.5^\circ$, $\Delta\beta \leq \pm 0.5^\circ$
- Axial static pressure gradient: $\left| \frac{d\bar{p}}{dx} \right| \leq 0.004 \quad 1/m$
- Turbulence: $\varepsilon \leq 0.1 \sim 0.14\%$
- Speed field coefficient in the model area: $\Delta\mu \leq 0.5\%$

The NH-2 wind tunnel facility is shown in Figure 1.

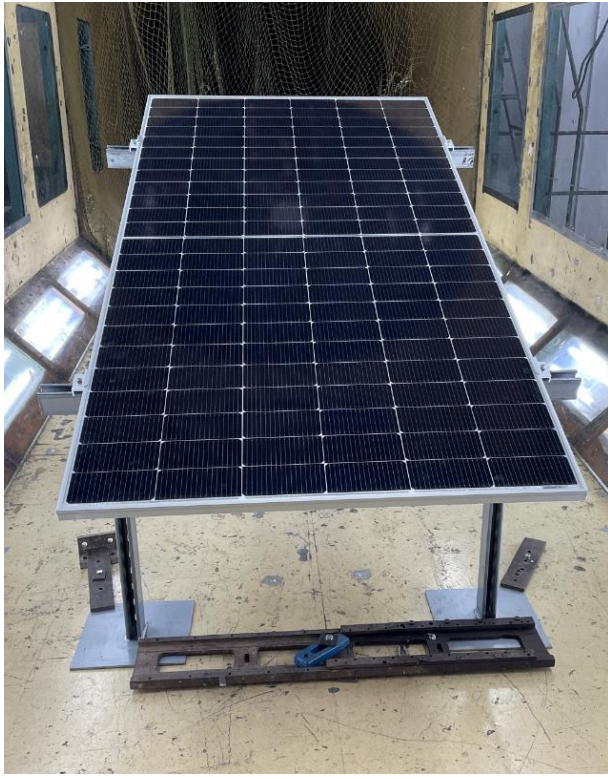
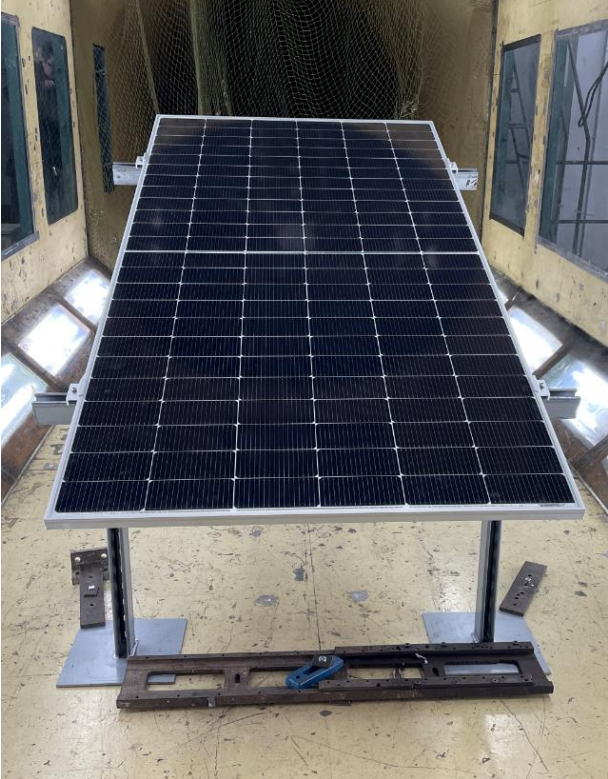
10	Test photo		
10.1	PV module facing wind (0°)

Before test		After test	
10.2	PV module back side facing wind (180°)

9	Test result		
9.1	Wind load resistance test		
PV module facing the wind (0°)	Wind direction	Wind speed	Duration Phenomenon
	0	/	All components of the sample are installed.
	10	5 min	No obvious vibration of the PV module detected, and no connection or component damage occurred.
	35 m/s	5 min	No obvious vibration of the PV module detected, and no connection or component damage occurred.
	45 m/s	5 min	Minor indentation of middle part of PV module detected, but no connection or component damage occurred.
	60 m/s	10 min	Obvious indentation of middle part of PV module detected, but no connection or component damage occurred.
Turn off the blower	/	No visual deformation, loosening or destruction of component detected on test sample after testing.	
PV module back side facing the wind (180°)	Wind direction	Wind speed	Duration Phenomenon
	0	/	All components of the sample are installed.
	10	5 min	No obvious vibration of the PV module detected, and no connection or component damage occurred.

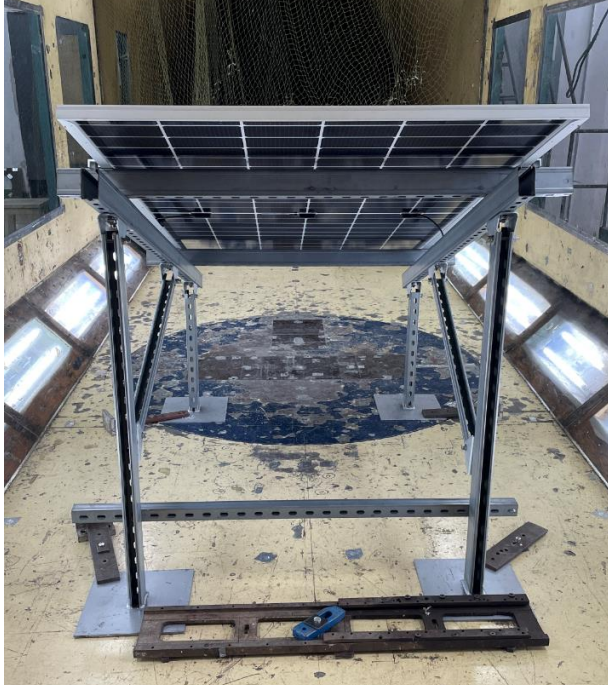
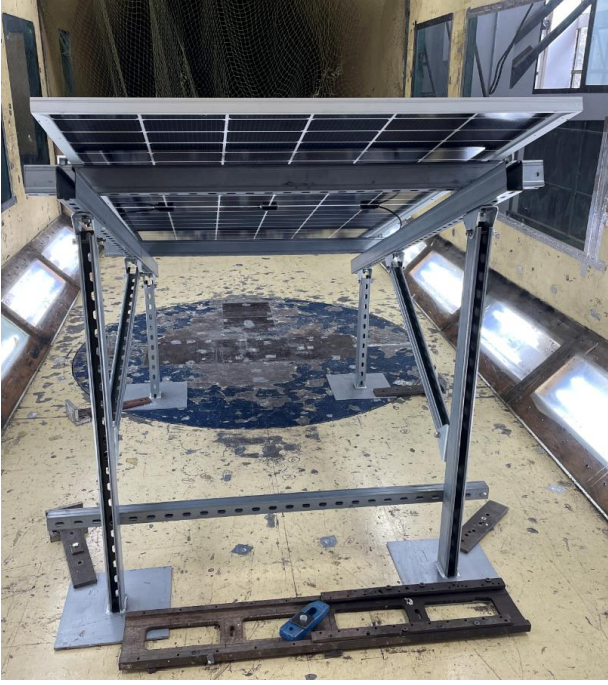
Before test		After test

35 m/s	5 min	No obvious vibration of the PV module detected, and no connection or component damage occurred.
	45 m/s	5 min	Minor bulges of middle part of PV module detected, but no connection or component damage occurred.
	60 m/s	10 min	Obvious bulges of middle part of PV module detected, but no connection or component damage occurred.
Turn off the blower	/	No visual deformation, loosening or destruction of component detected on test sample after testing.
